## TEST REPORT

No. : XMIN2112013228ML

Sample Name : ISU DRILL PIPE HANDLING TOOL 1500MM  
Material and Mark : Plastic and fiberglass  
Other Information : ISU-DRP-15M

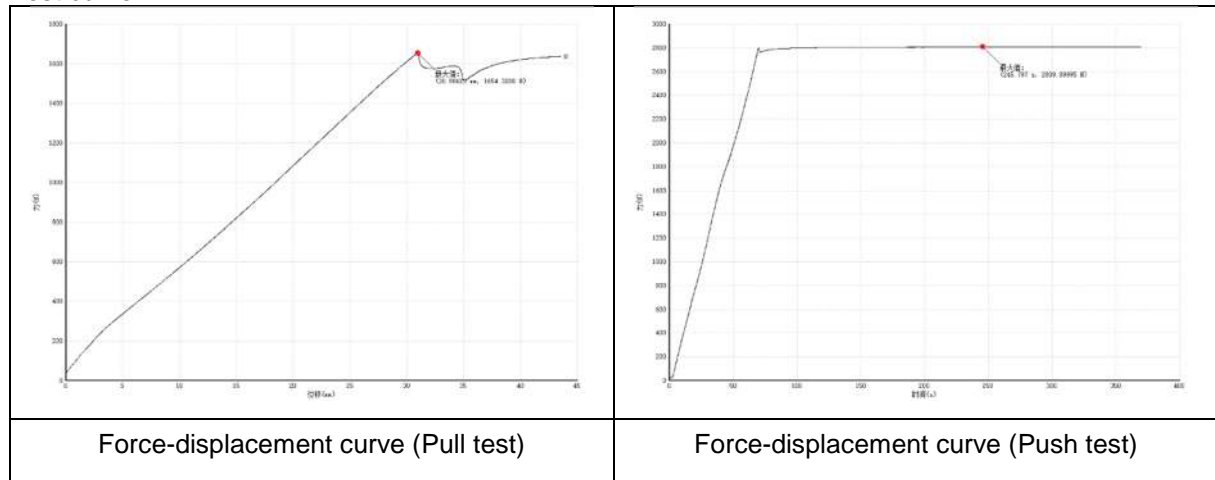
**Test curve:**

Test Item	Test Result
Pull test	When the force reached 1650N the sample was not damaged
Push test	When the force reached 2800N the sample was not damaged.

Test method: according to the client's requirements, fixed the sample on the test machine. Apply the pull force as a rate of 5mm/min till the force reaches 1650N, then hold the force for 5 min if the sample without obvious deformation. Observe whether the sample was damage after the test.

Test method: according to the client's requirements, fixed the sample on the test machine. Apply the push force as a rate of 5mm/min till the force reaches 2800N, then hold the force for 5 min if the sample without obvious deformation. Observe whether the sample was damage after the test.

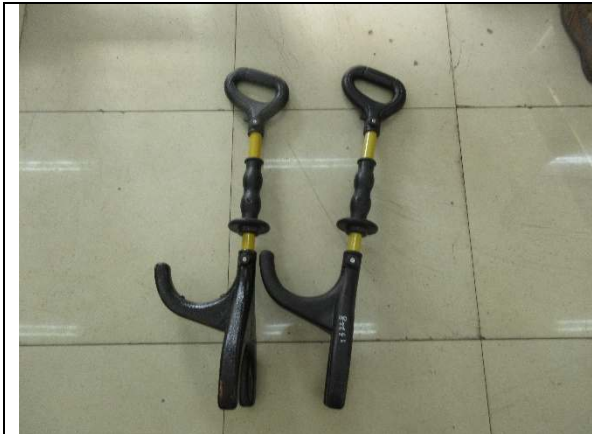
Photo1: Samples

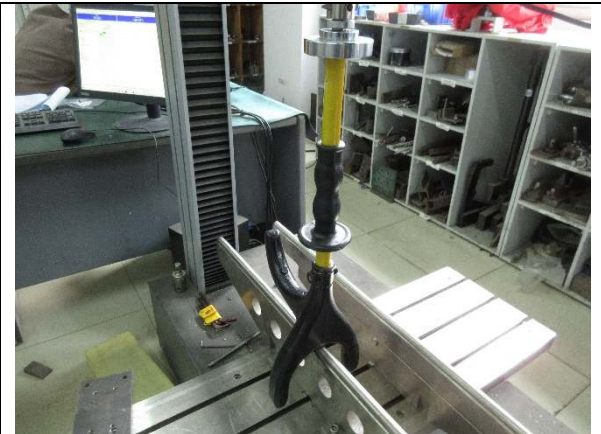
Photo2: During test (Push test)

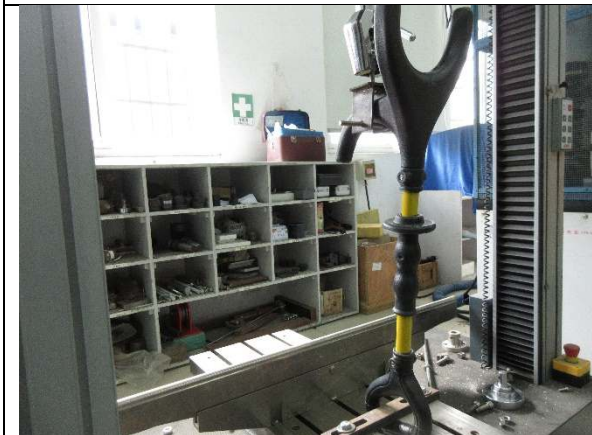
Photo3: During test (Pull test)

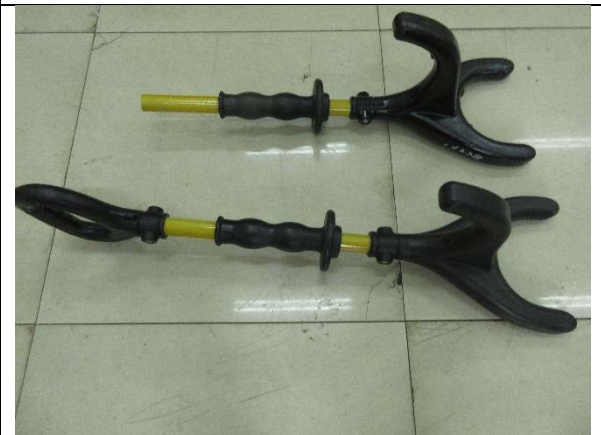
Photo4: The samples after the test
