TEST REPORT

No. : XMIN2112013230ML

Sample Name : ISU DRILL PIPE CASING TOOL 1500MM
Material and Mark : Plastic and fiberglass
Other Information : ISU-DCT-15M

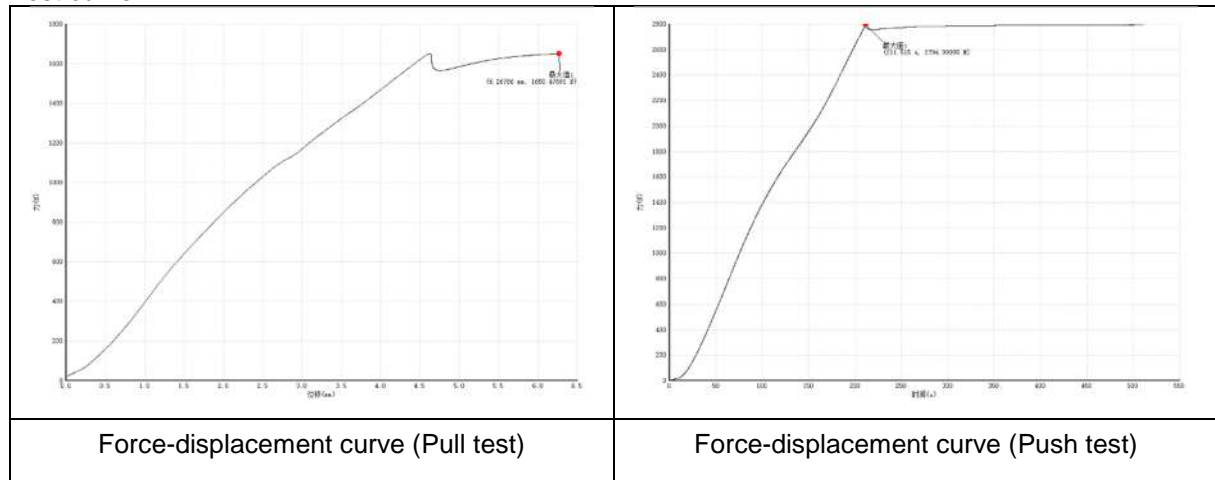
Test curve:

Test Item	Test Result
Pull test	When the force reached 1650N the sample was not damaged
Push test	When the force reached 2800N the sample was not damaged.

Test method: according to the client's requirements, fixed the sample on the test machine. Apply the pull force as a rate of 5mm/min till the force reaches 1650N, then hold the force for 5 min if the sample without obvious deformation. Observe whether the sample was damage after the test.

Test method: according to the client's requirements, fixed the sample on the test machine. Apply the push force as a rate of 5mm/min till the force reaches 2800N, then hold the force for 5 min if the sample without obvious deformation. Observe whether the sample was damage after the test.

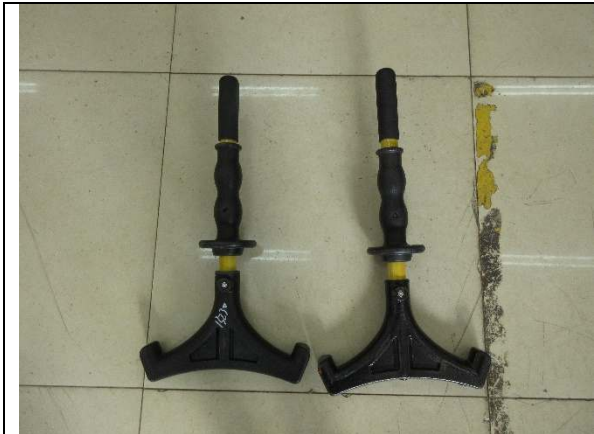
Photo1: Samples

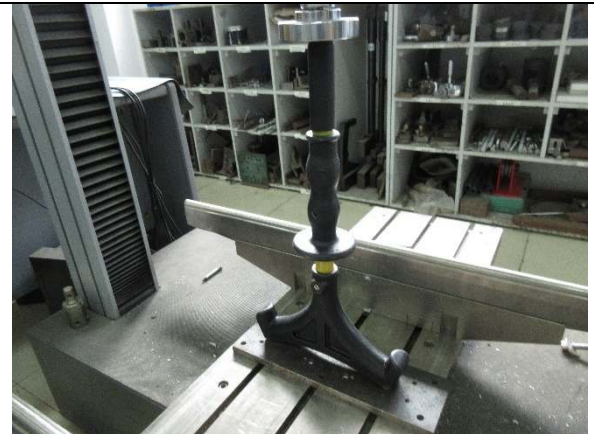
Photo2: During test (Push test)

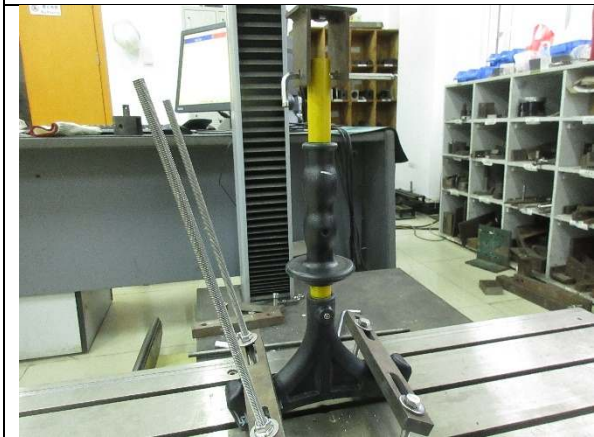
Photo3: During test (Pull test)

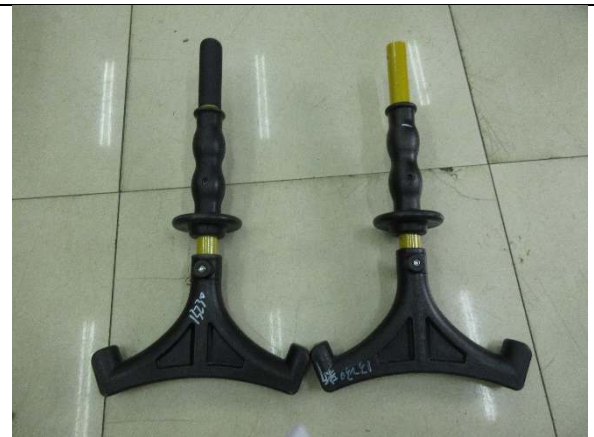
Photo4: The samples after the test
