TEST REPORT

No. : XMIN2112013229ML

Sample Name : ISU DRILL PIPE BACKPACK TOOL 1500MM
Material and Mark : Plastic and fiberglass
Other Information : ISU-DBT-15M

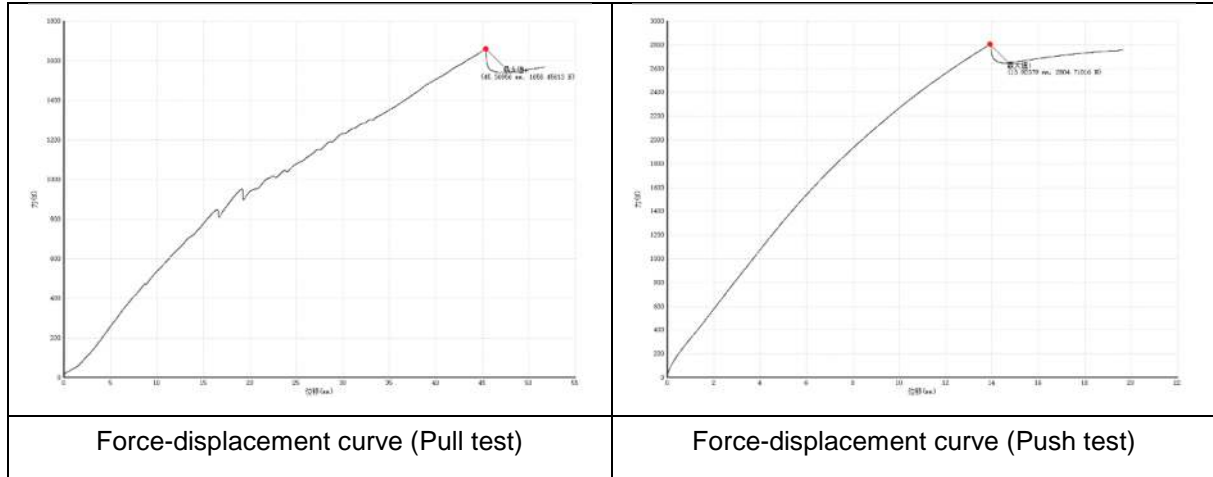
Test curve:

Test Item	Test Result
Pull test	When the force reached 1650N the sample was not damaged
Push test	When the force reached 2800N the sample was not damaged.

Test method: according to the client's requirements, fixed the sample on the test machine. Apply the pull force as a rate of 5mm/min till the force reaches 1650N, then hold the force for 5 min if the sample without obvious deformation. Observe whether the sample was damage after the test.

Test method: according to the client's requirements, fixed the sample on the test machine. Apply the push force as a rate of 5mm/min till the force reaches 2800N, then hold the force for 5 min if the sample without obvious deformation. Observe whether the sample was damage after the test.

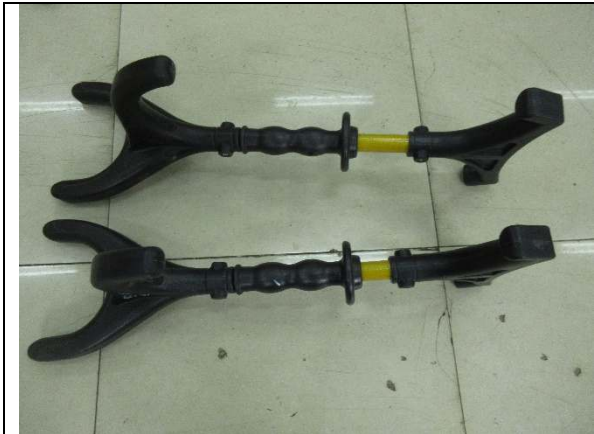
Photo1: Samples

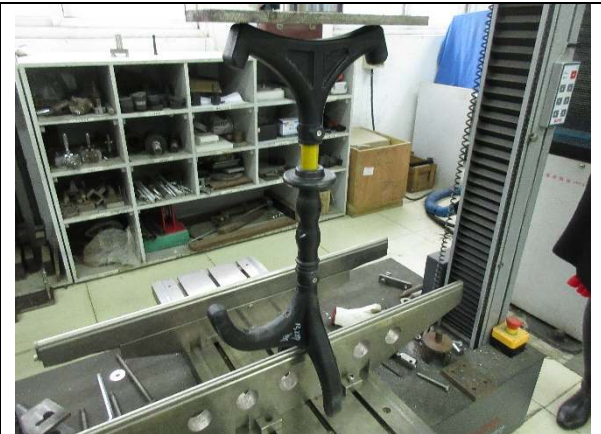
Photo2: During test (Push test)

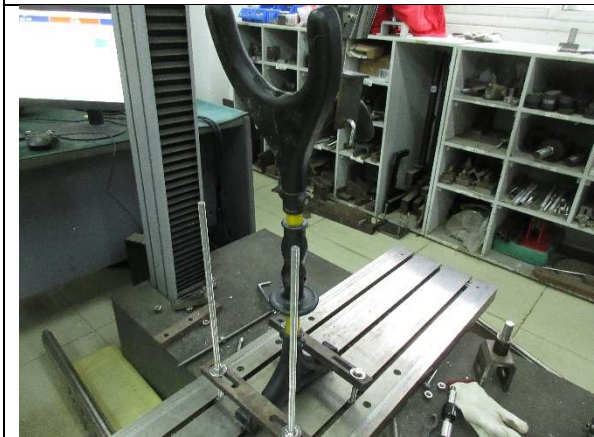
Photo3: During test (Pull test)

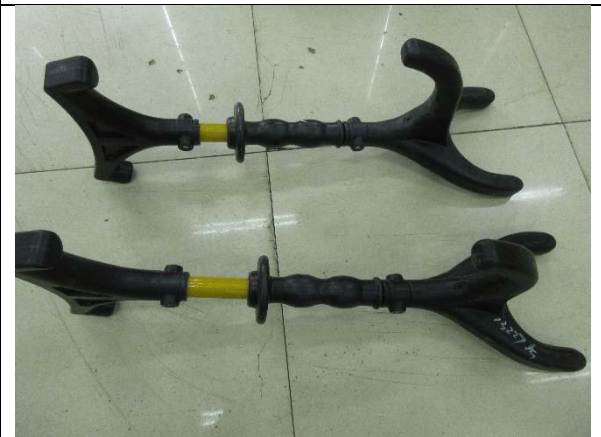
Photo4: The samples after the test
