No.: XMIN2112013227ML

Sample Name : ISU GENERAL CARGO HANDLING TOOL 1500MM

Material and Mark : Plastic and fiberglass

Other Information : ISU-CHT-15M

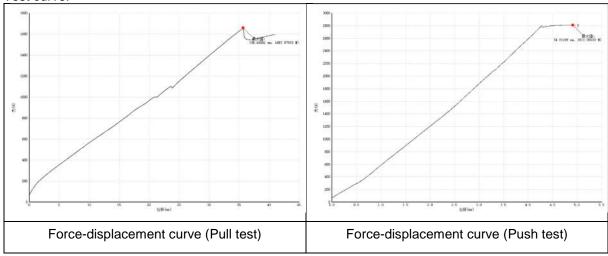
Test curve:

Test Item	Test Result
Pull test	When the force reached 1650N the sample was not damaged
Push test	When the force reached 2800N the sample was not damaged.

Test method: according to the client's requirements, fixed the sample on the test machine. Apply the pull force as a rate of 5mm/min till the force reaches 1650N, then hold the force for 5 min if the sample without obvious deformation. Observe whether the sample was damage after the test.

Test method: according to the client's requirements, fixed the sample on the test machine. Apply the push force as a rate of 5mm/min till the force reaches 2800N, then hold the force for 5 min if the sample without obvious deformation. Observe whether the sample was damage after the test.
